# **The Performance of Low-Rise Open Span Heavy Steel Structures In Extreme Winds**

**Joe R. Charlton, B.S., P.E.**

**A REPORT**

**June, 1997**

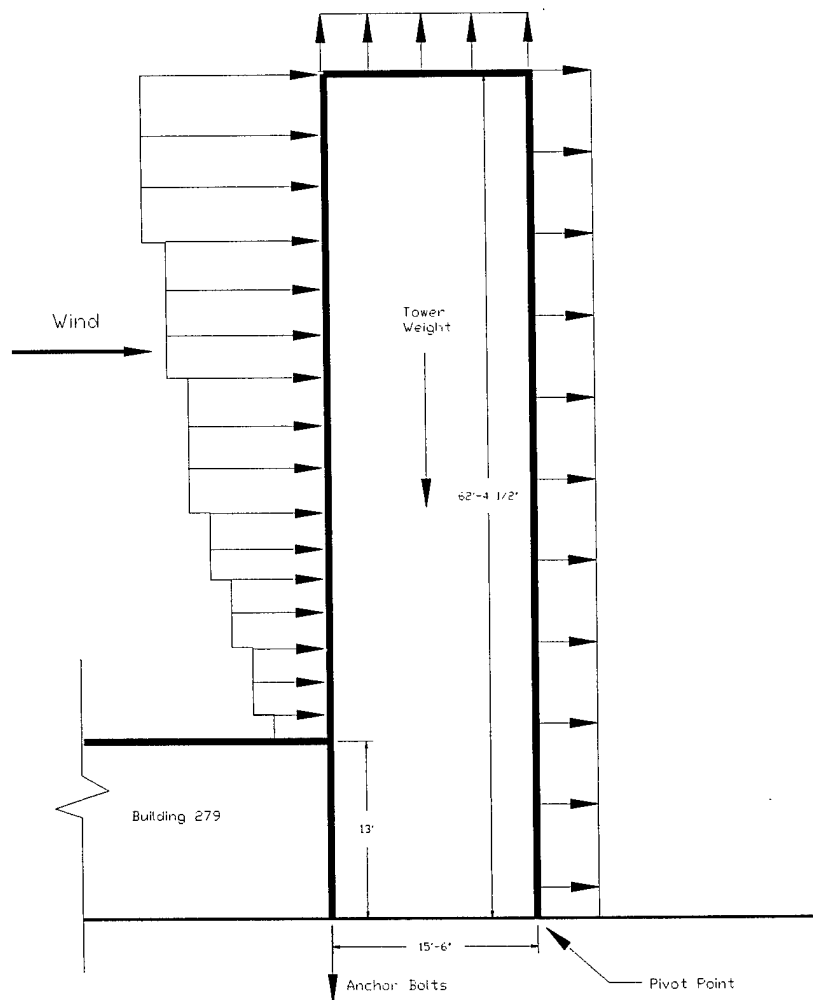
Figure 4.11 Forces Acting on Parachute Tower

The wind that caused the collapse of the parachute tower was generated by the Altus, Oklahoma tornado that was described earlier in Section 3.5. The wind caused the collapse of the parachute tower by generating enough force to cause failure of the column anchor bolts and also overcome the righting moment generated by the weight of the building. An illustration of the forces acting on the structure can be seen in Figure 4.11, below.

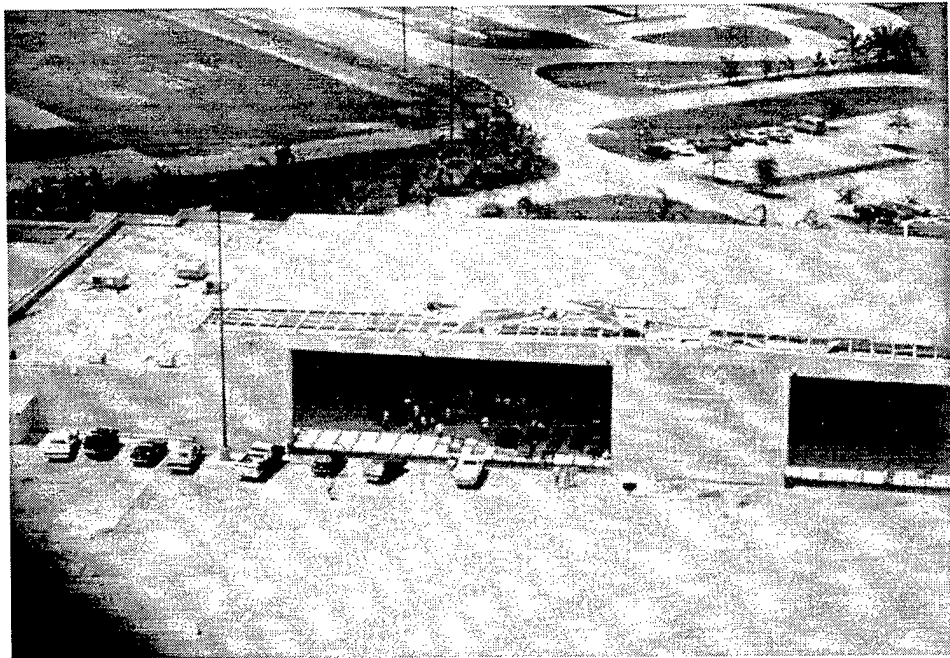
Figure 4.24 Elevation of Beechcraft Hangar

The main component that was damaged on all three hangars was the roof decking. The corrugated siding on the front of the Beechcraft hangar also received minor damage at the door pocket, see Figure 4.25.

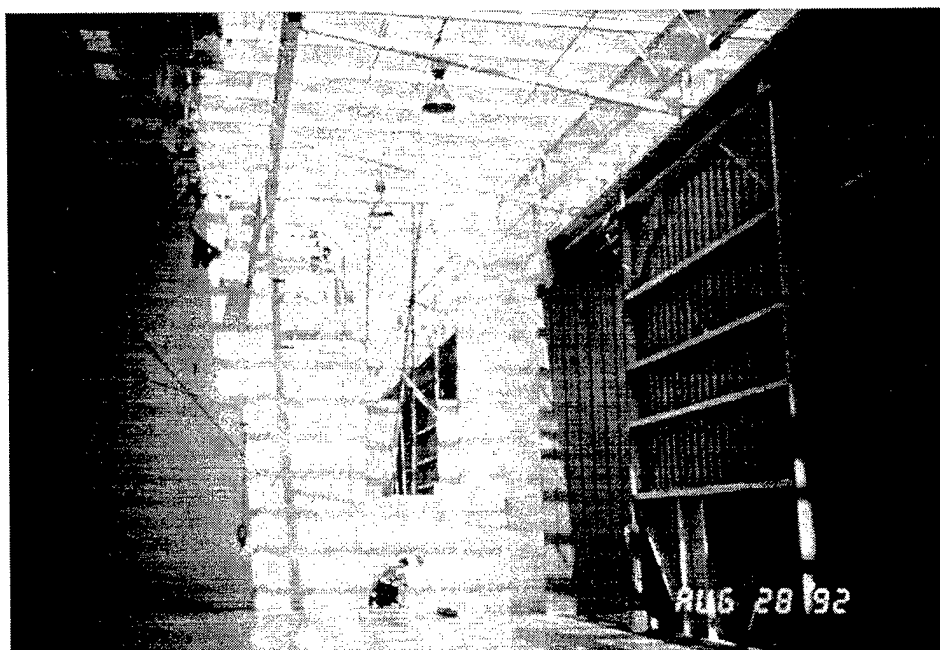
Figure 4.26 Interior Elevation of Beechcraft Hangar

The Beechcraft hangar shown in Figures 4.23, 4.24, and 4.25 is approximately 200 feet long, 60 feet wide, and 40 feet tall. The structure has a gable roof with a very slight pitch (approximately 1/4" per foot). The exterior walls are covered with corrugated metal siding and the roof is covered with corrugated metal decking. The main structural system is made up of wide flange steel columns, large custom girders, and z shape roof purlins. The lateral loads are transferred to the foundation via steel cross bracing running between the columns. All of the main structural elements can be seen in Figure 4.25. The other two hangars that are shown in Figure 4.26 are very similar in size and construction to the Beechcraft hangar.
